MG Home Inspections

Home Inspection Report

5678 W 9th St.

Inspected on Wed, Jan 1 2020 at 8:00 AM

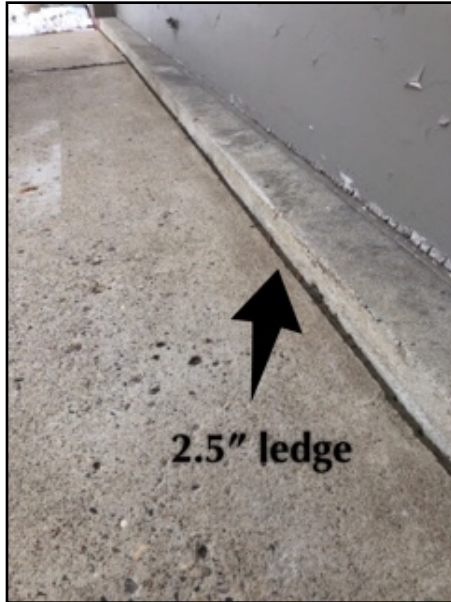
Figure 1-1

The driveway cement pad next to the garage has settled causing a 2.5 inch ledge when entering the garage. Enter with caution.

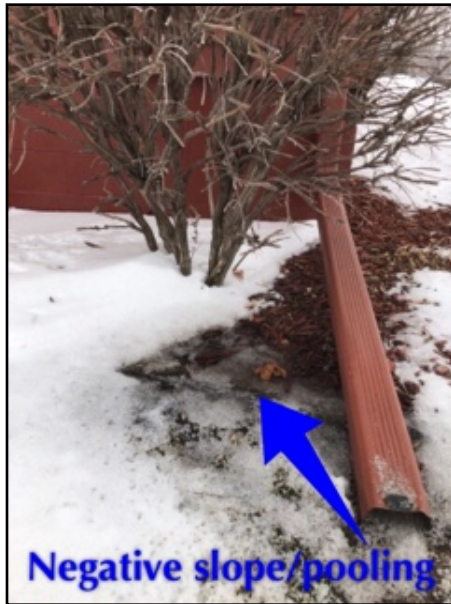
Figure 2-1

Some areas of settled soil/negative slope observed on the east side of the house near the downspout. (see example) Keeping landscape levels higher near the foundation and sloping away will help prevent potential water intrusion to the basement along with minimizing excess wet soil pressure against the foundation.

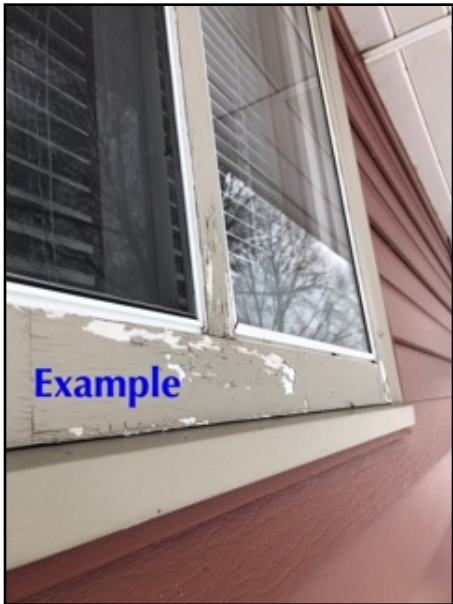
Figure 3-1

Areas of peeling paint observed on some window trims. (see examples)
Prep/paint all necessary areas to prevent further water/wood contact.

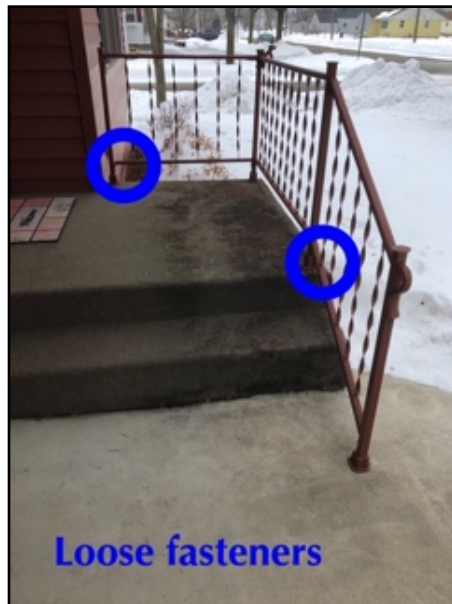
Figure 5-1

Loose fastener bolts observed on the front stairs. Tighten the fasteners.

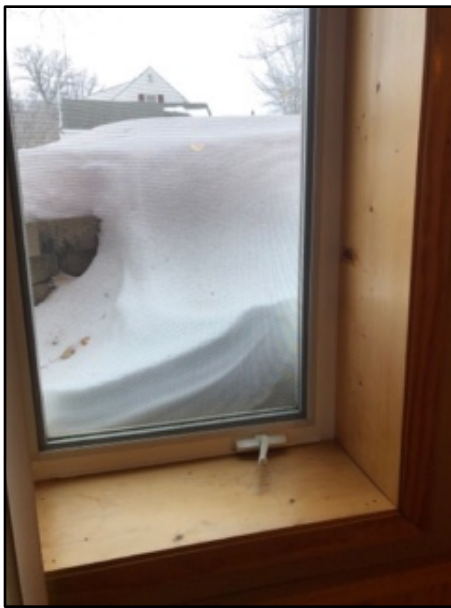
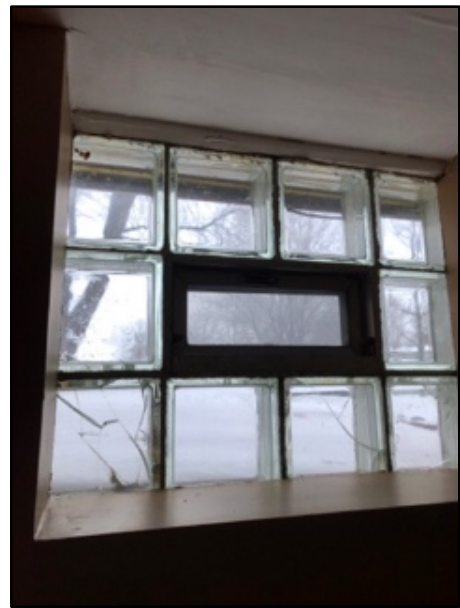
Unable to test egress windows function at time of inspection due to snow obstruction.

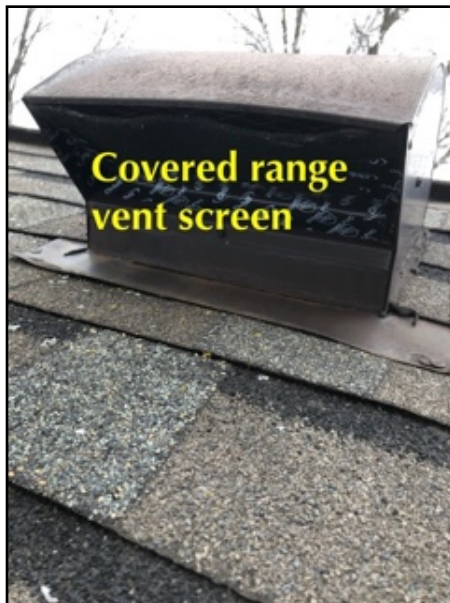
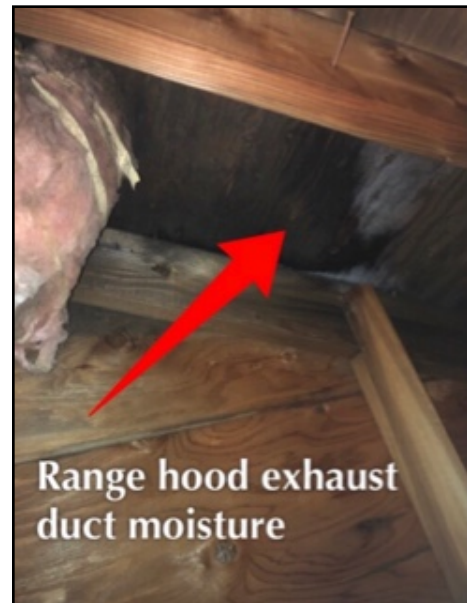
2) Comment 15: A kitchen range vent screen cover has been installed on the roof vent. This should be clear of obstruction for proper exhaust escape. Signs of moisture observed on the plywood sheathing in the attic around the vent connection. Repair to prevent further issues.

A kitchen range vent screen cover has been installed on the roof vent. This should be clear of obstruction for proper exhaust escape. Signs of moisture observed on the plywood sheathing in the attic around the vent connection. Repair to prevent further issues.

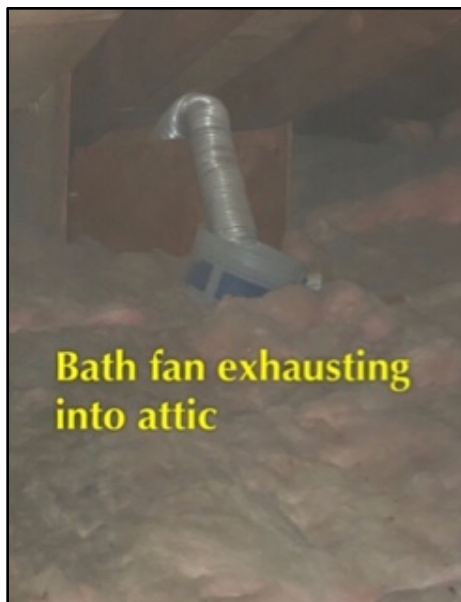
Figure 17-1

Bath fan exhausts into the attic. It is recommended that it exits the house completely to prevent unwanted moisture in the attic.

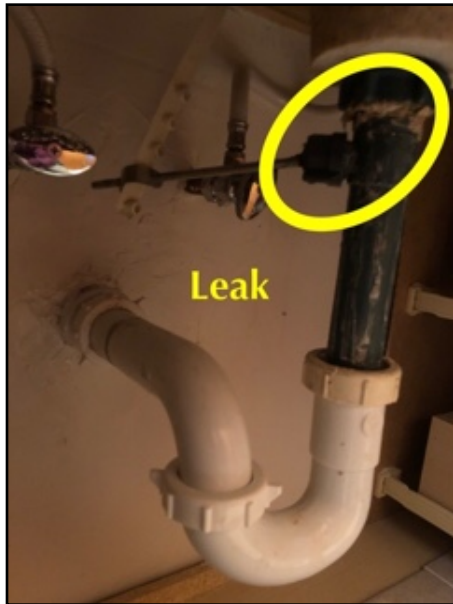
Figure 18-1

3) Comment 18: Leaking observed at the main floor bathroom sink plug mechanism. Repair.

Leaking observed at the main floor bathroom sink plug mechanism. Repair.

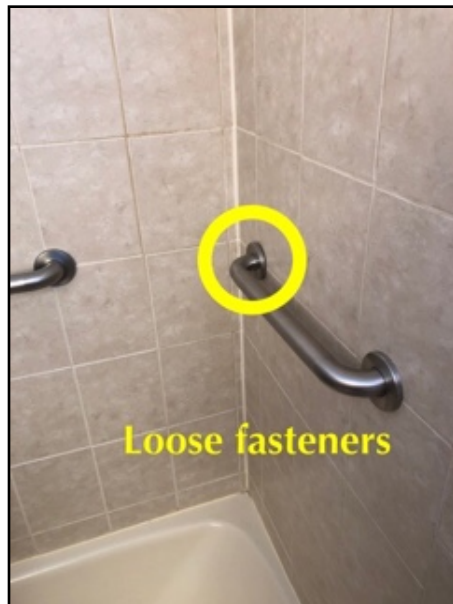
Figure 19-1

Loose fasteners screws observed on the main floor shower handle. Tighten the fasteners.

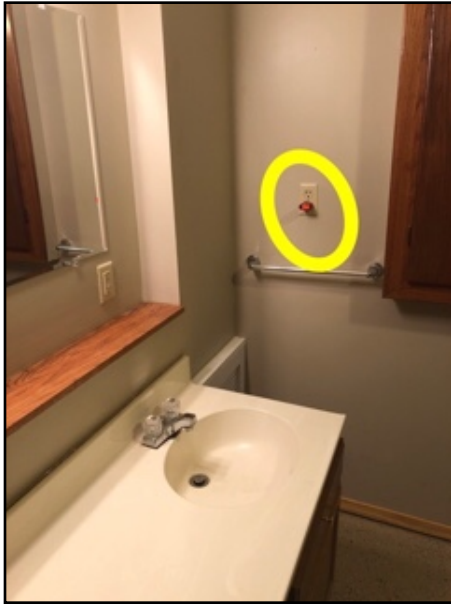
Figure 20-1

The downstairs bathroom receptacle near the electrical panel is within 3' of the sink and is not GFCI protected. Recommend adding GFCI protection as a safety upgrade.

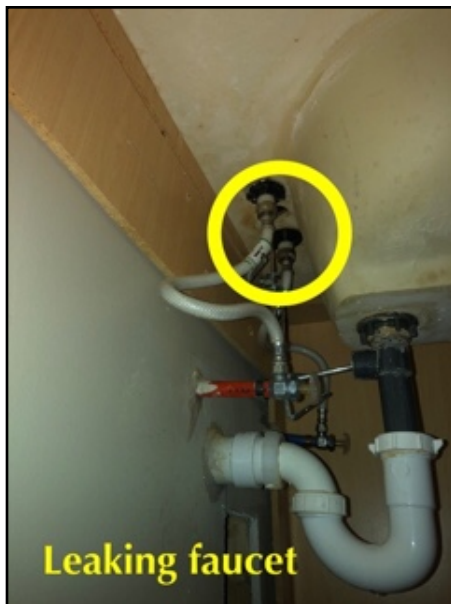
Figure 21-1

4) Comment 21: Leak observed on the bottom connections of the downstairs bathroom vanity faucet. Repair.

Leak observed on the bottom connections of the downstairs bathroom vanity faucet. Repair.

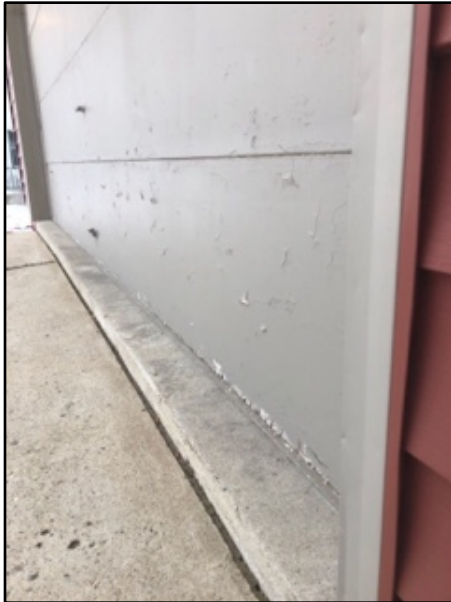
Figure 23-1

Peeling/chipping paint observed on the overhead garage door. Also, some deterioration observed at the bottom near the seal.

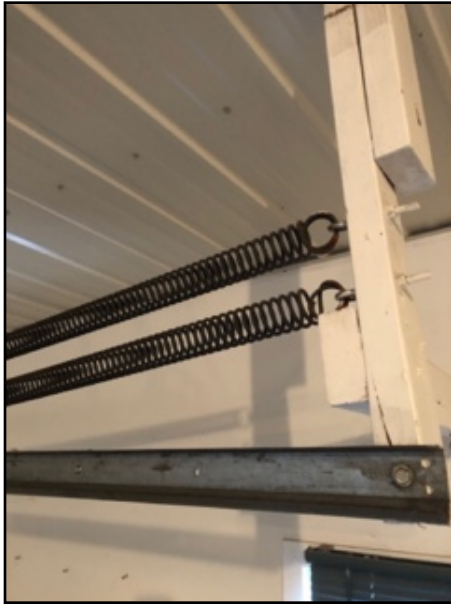
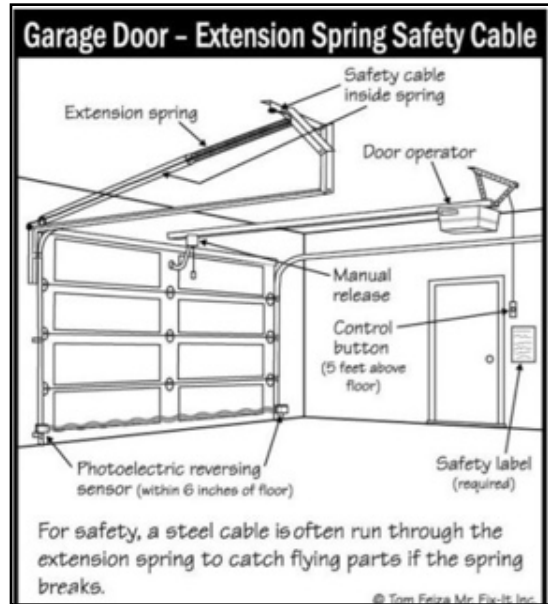
Missing spring containment cable. For safety reasons, it is recommended that a safety wire/cable is ran through the middle of the garage door springs to prevent potential spring-whip if the springs were to break or come unattached.

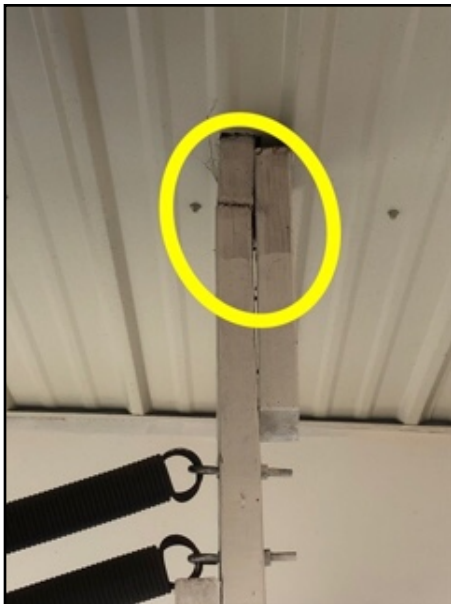
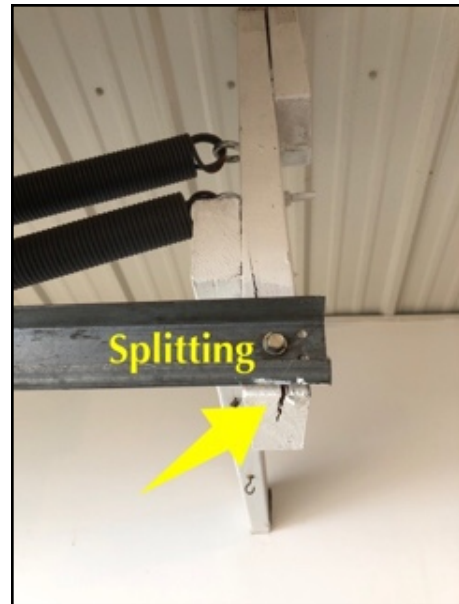
Non-typical method of garage door spring brace wooden splice. Consider adding through-bolts on the splicing board for adequate support. Also, splitting of the board observed where the rail fastener meets wooden brace. Monitor/repair as necessary as a safety upgrade.

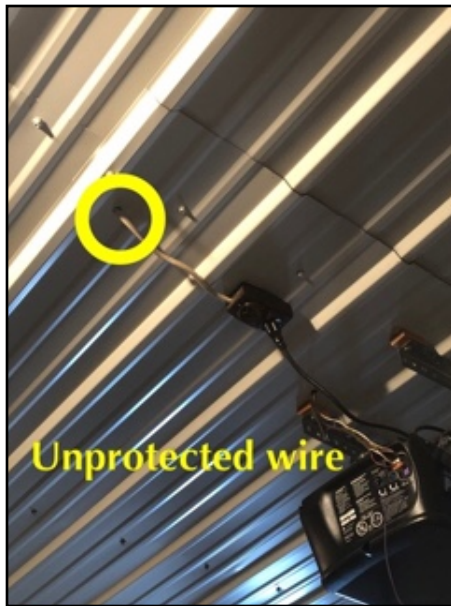
Figure 26-1

Wires penetrating through sharp material such as steel should have proper protective connectors. Missing connector on the garage door opener receptacle wire.
