MG Home Inspections

Home Inspection Report

5678 W 9th St.

Inspected on Wed, Jan 1 2020 at 8:00 AM

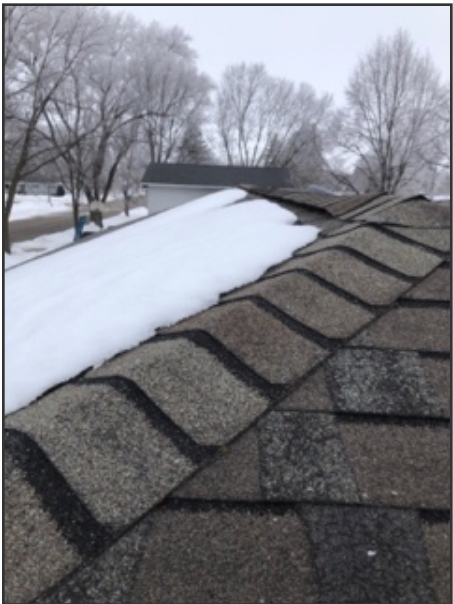
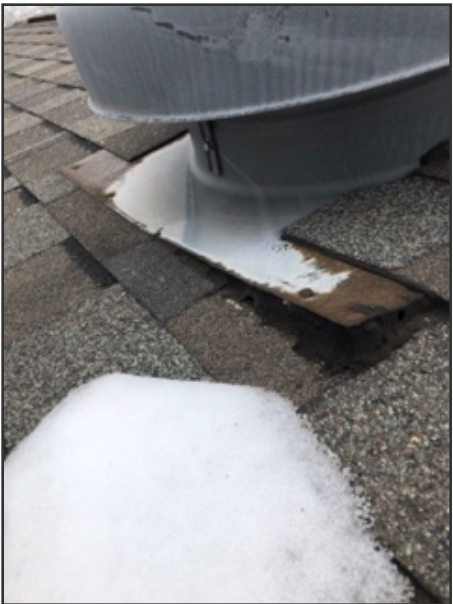
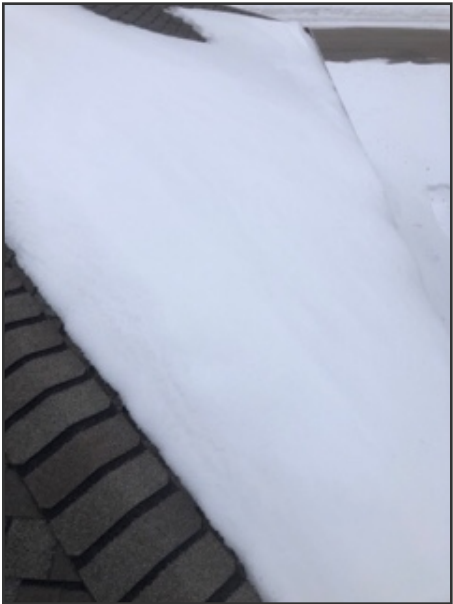
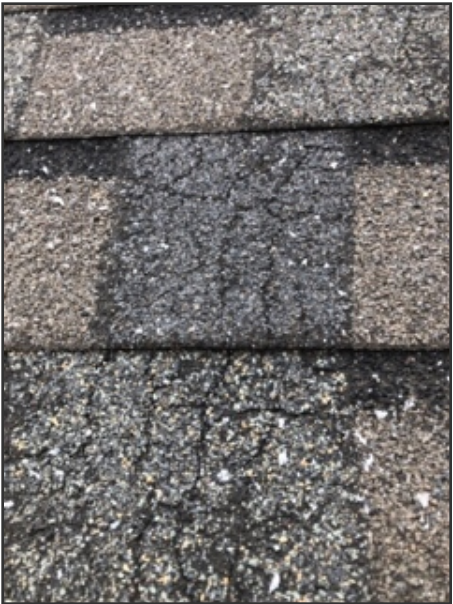
The shingles are showing signs of their age as they show deterioration/general cracking, are becoming brittle and are at or near the end of their life expectancy. Recommend having a roofing contractor evaluate for life remaining and provide an estimation of replacement cost.

Some exposed nail heads observed on boots, trim, flashing and ridge caps. Common finding. (see examples) It is recommended to seal ANY exposed fasteners or gaps with blackjack or caulk to prevent potential water intrusion.

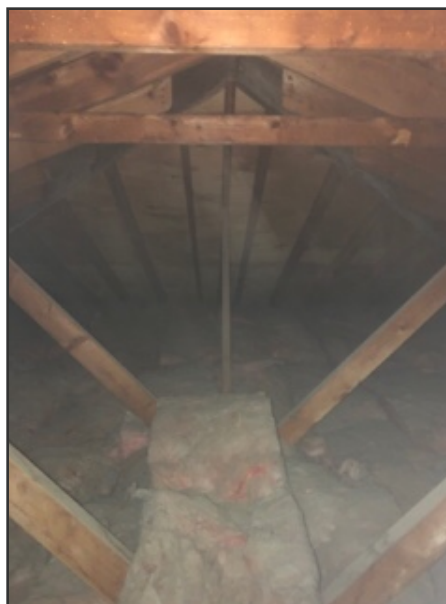
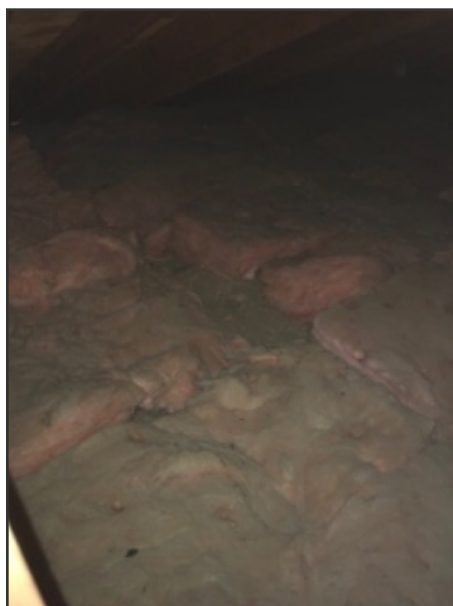
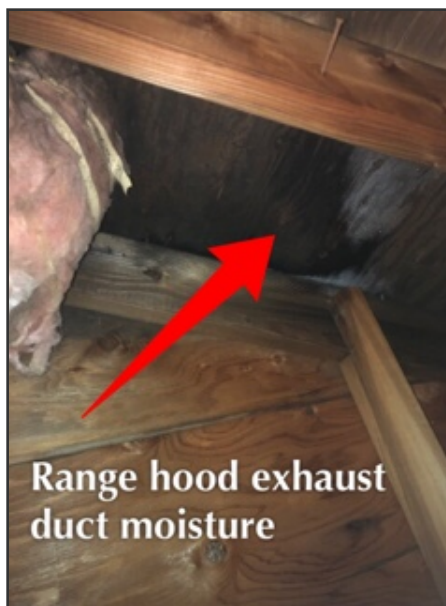
Bath fan exhausting
into attic

Bath fan exhausts into the attic. It is recommended that it exits the house completely to prevent unwanted moisture in the attic.

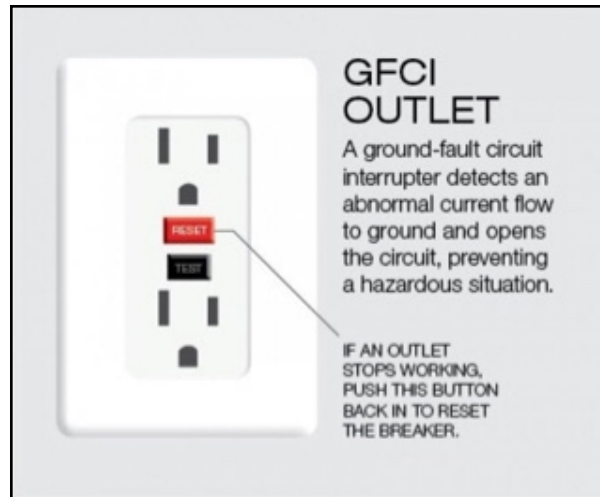
The kitchen, garage, downstairs bathroom and outdoor receptacles are not all GFCI protected. It is recommended to install GFCI protection in these "wet location" areas as a safety upgrade.

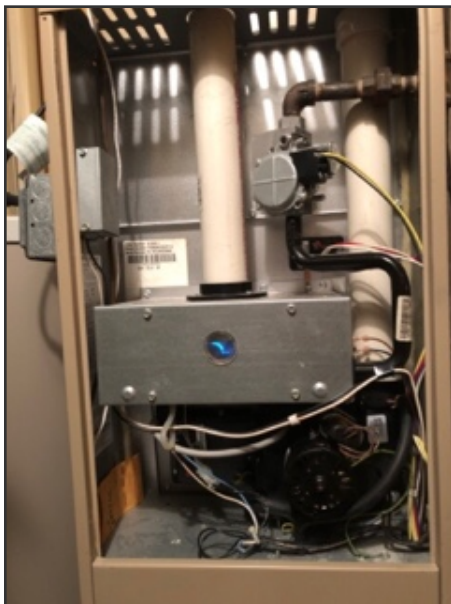
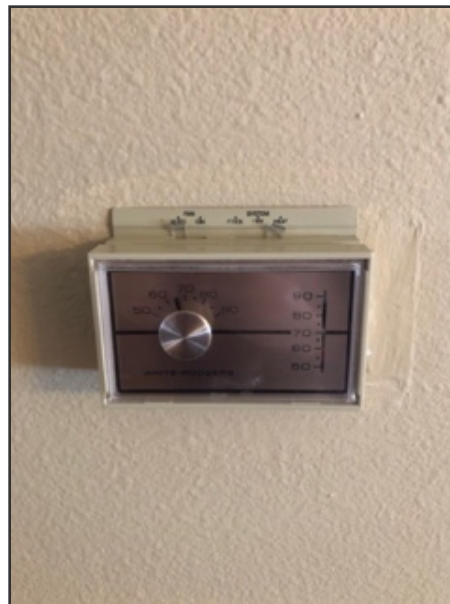
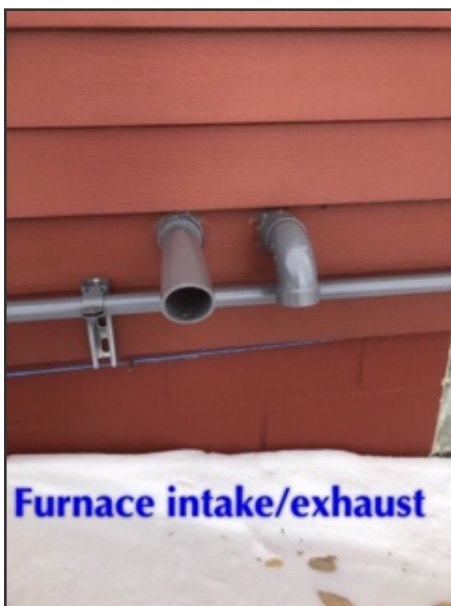
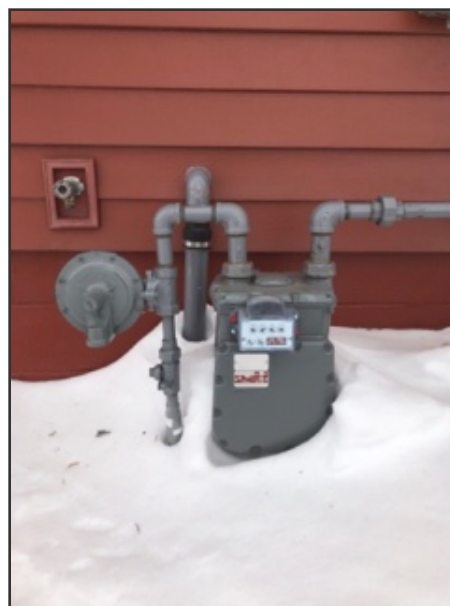
Type of Equipment:	Forced Air Furnace
Manufacturer :	York
Manufacturer Date:	2002
Age in Years:	18
Life Expectancy :	Approximately 25-30 years
Type of Distribution:	Metal Ducting
Thermostat Location:	Hallway

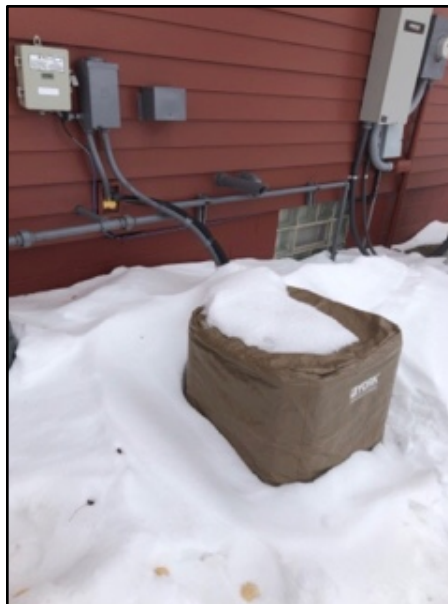
Cooling Unit:

Type of Equipment:	Central Air Conditioner
Manufacturer:	Likely York

Unable to test air conditioning unit due to low outdoor temperatures. Attempting to run during temperatures lower than 60 degrees could potentially damage the unit.

Unable to view the air conditioner due to a seasonal cover.

Air Conditioner Maintenance :	Continue to service/maintain the outdoor unit as necessary keeping the air fins clean/clear of obstruction to extend the life of the unit
-------------------------------	---

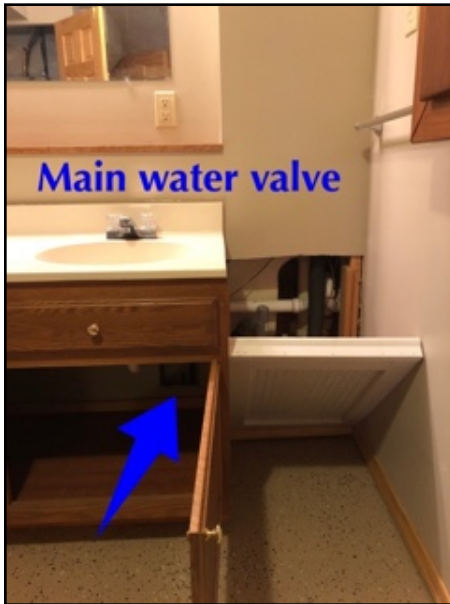
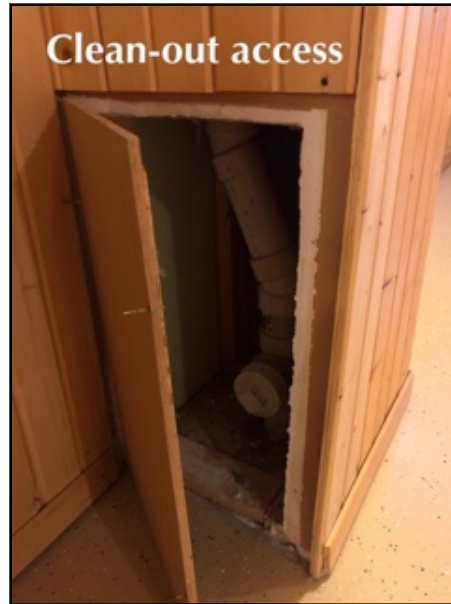
Water Source:

Location of Main Water Shut-off:	Basement Bathroom
Main Supply Pipe :	Copper Main
Distribution Lines:	Copper
Waste Pipe Main:	PVC Main
Waste Pipe Lines:	PVC
Waste Pipe Venting:	PVC and exits the roof
Floor Drain:	Inspected

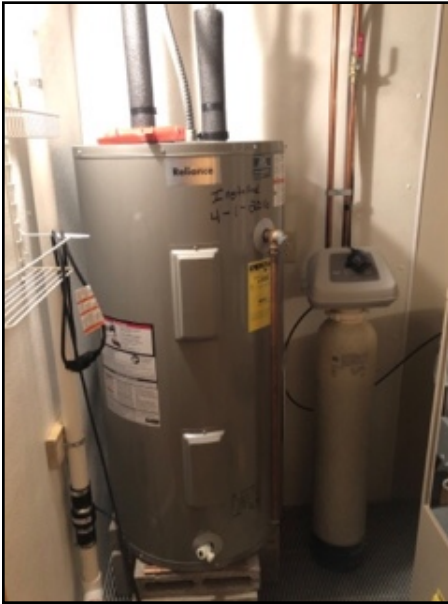
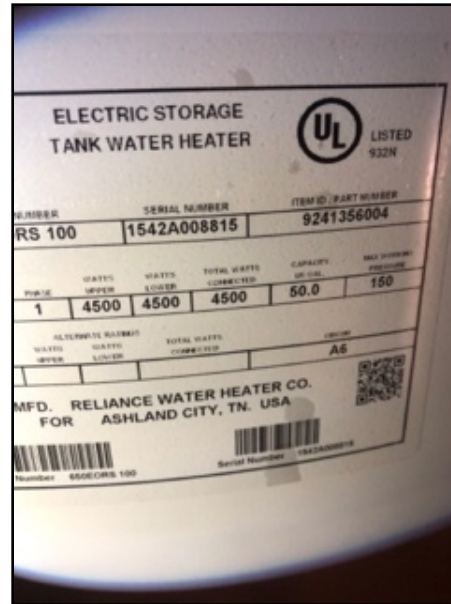
Water Heater:

Water Heater Energy Type:	Electric
Water Heater Manufacturer :	Reliance
Manufacturer Date:	2015
Age in Years:	5
Life Expectancy:	Average life expectancy of a water heater is 15 years depending on water quality.
Water Heater Capacity:	50 gal

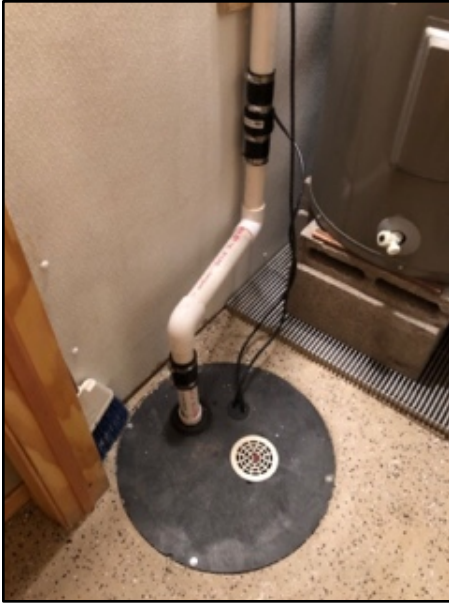
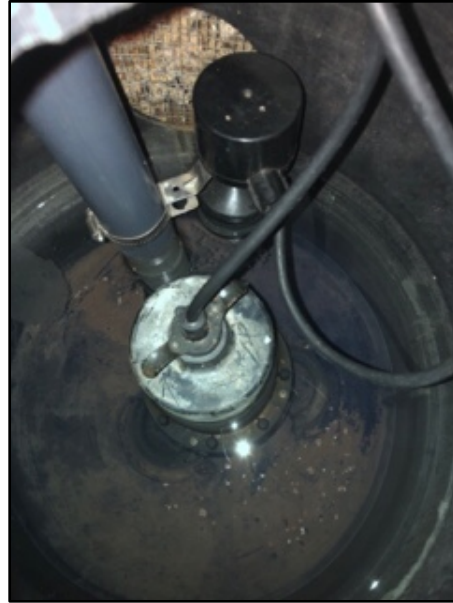
Sump Pump View:

Sump Pump Operation:	Operational at time of inspection
Sump Pump Discharge Location:	Exits side of the house
Sump Pump Receptacle :	Not GFCI protected
Drainage Tile?:	Not Observed
Check Valve:	Present

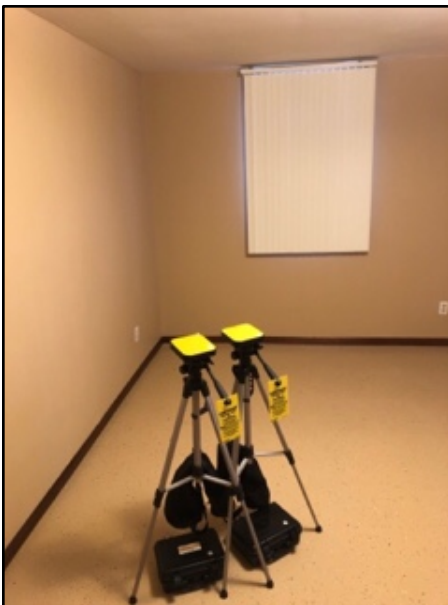
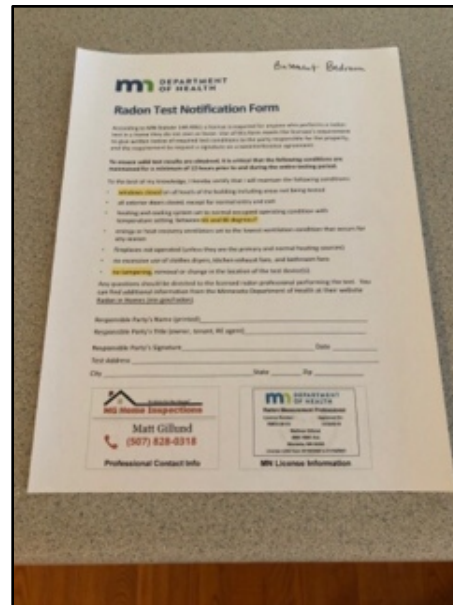
Radon Testing:

Comment 34:

License radon testers are required to do "tester crosschecks" on a scheduled basis. This is why there are two devices next to each other at this house.
